Gear Check Quick Reference – Updated 20 November 2026

This document references the ITCC Approved Devices List, currently approved for use in ISA tree climbing competitions, along with associated safety notices, recalls, and known inspection points relevant to gear checks. It is not an exhaustive catalog of all tree-climbing equipment ever manufactured, nor does it contain all known information about every product.

Recalls & Safety Notices - Gear Inspection Quick Reference - Reference Documents and Visual Aids

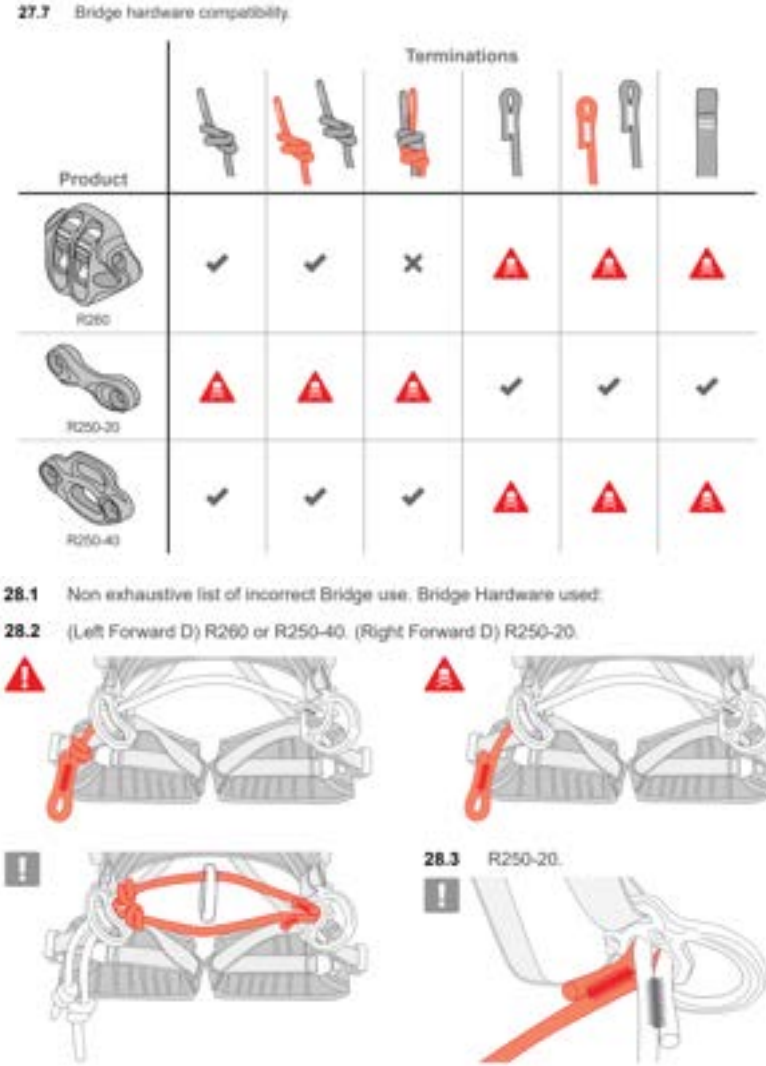
Item Name	Inspection Parts	Serial Numbers Affected	Notes, Reference documents, images, comments, etc.
DMM Kinisi Harness	Bridge terminations		Adjustable bridges SHALL NOT be cut Graphic from Kinisi MAX user instructions page 48-49 (pdf page 25/74)
			DMM_KINISIMAX_UG.pdf

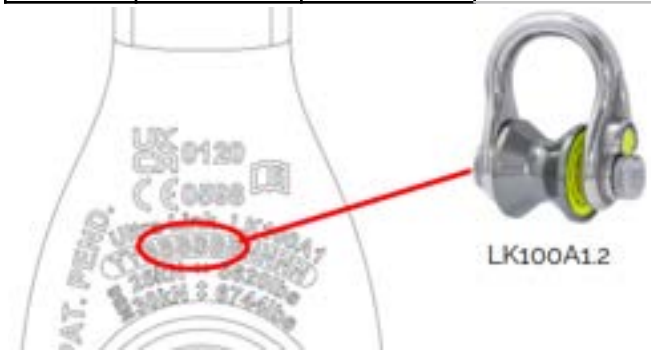
Re-worked UltraLinks

Item Name	Inspection Parts	Serial Numbers Affected	Notes, Reference documents, images, comments, etc.
ISC Quicklink Ultralink	Call for Head Judge, Head Tech, Chair for consultation	Batch numbers LK100: 168276, 168153, 166671, 167961 LK101: 167962, 166675,168231, 168155, 168277	Recall applies to all units in circulation from February 28 to March 13, 2023
			ISC_UltraLink-Notice.pdf

How to identify a re-worked device

All recalled UltraLink devices from the affected batches, which have been re-worked in our factory, have been Dot-matrix marked with a letter 'A'.

The re-work marking is located on the side of the guard which surrounds the spring-loaded button. This 'A' marking enables users and PPE Inspectors to identify that a device that falls within the recalled batch range, has undergone rework, and has been deemed suitable for return to service.

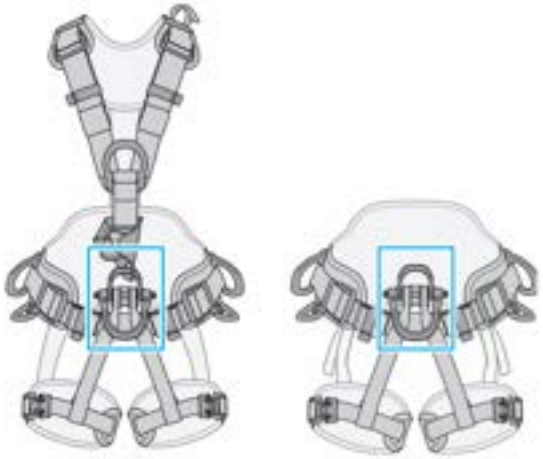
Item Name	Inspection Parts	Serial Numbers Affected	Notes, Reference documents, images, comments, etc.
Petzl Harness	Astro	Astro Bod Astro Bod Fast Astro Sit Fast Canyon Guide All serial numbers up to 23J 0000000 000 included	Detection of a defect on the gated opening attachment point of an ASTRO harness.
			Petzl_ASTROharness.pdf

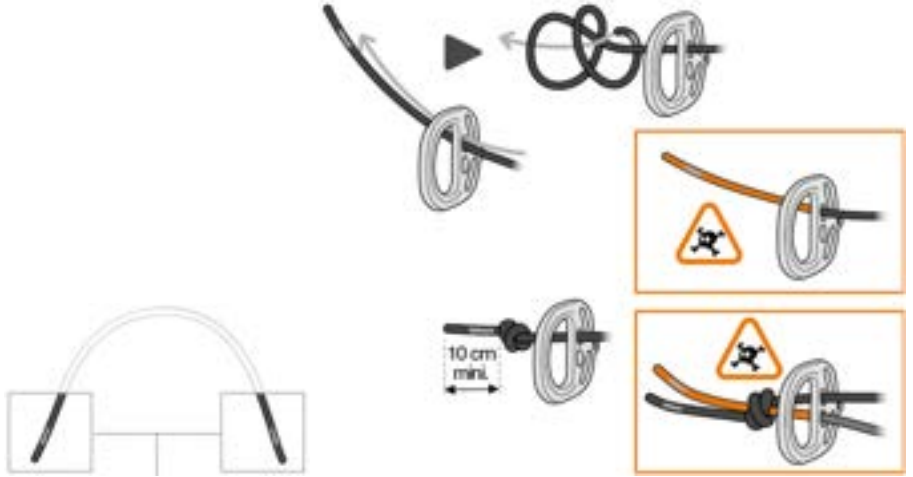
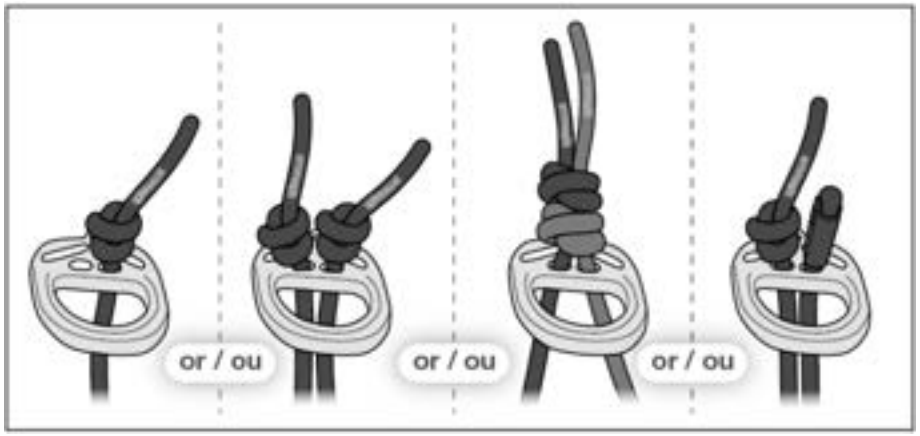
Item Name	Inspection Parts	Serial Numbers Affected	Notes, Reference documents, images, comments, etc.
Petzl Harness Sequoia	Knottable bridge	(2026, Plus 2026, 2019, SRT 2019)	Verify knot configurations
			Petzl_technical-notice-knottable-attachm…

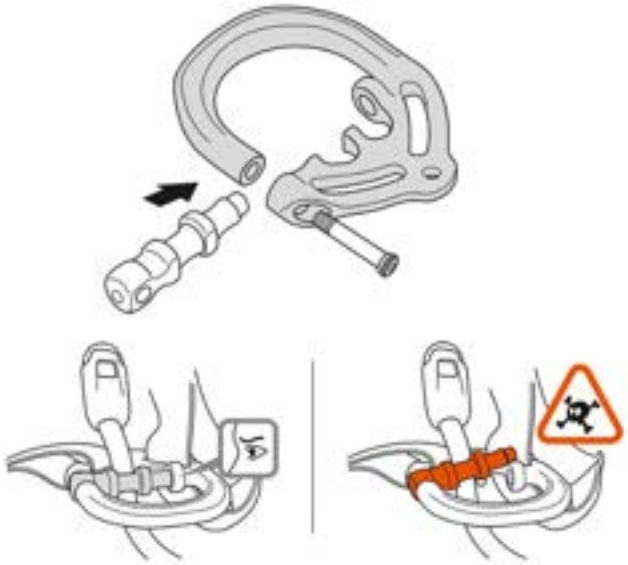
Item Name	Inspection Parts	Serial Numbers Affected	Notes, Reference documents, images, comments, etc.
Petzl Harness Sequoia	Sequoia 2019, lower D gate		Verify lower D gate is properly closed - Make sure the screws are not over-torqued
			Petz_SequoiaSequoiaSRTharnesses_Safet…
			Petzl_EnsureScrewsProperlyTightened.pdf

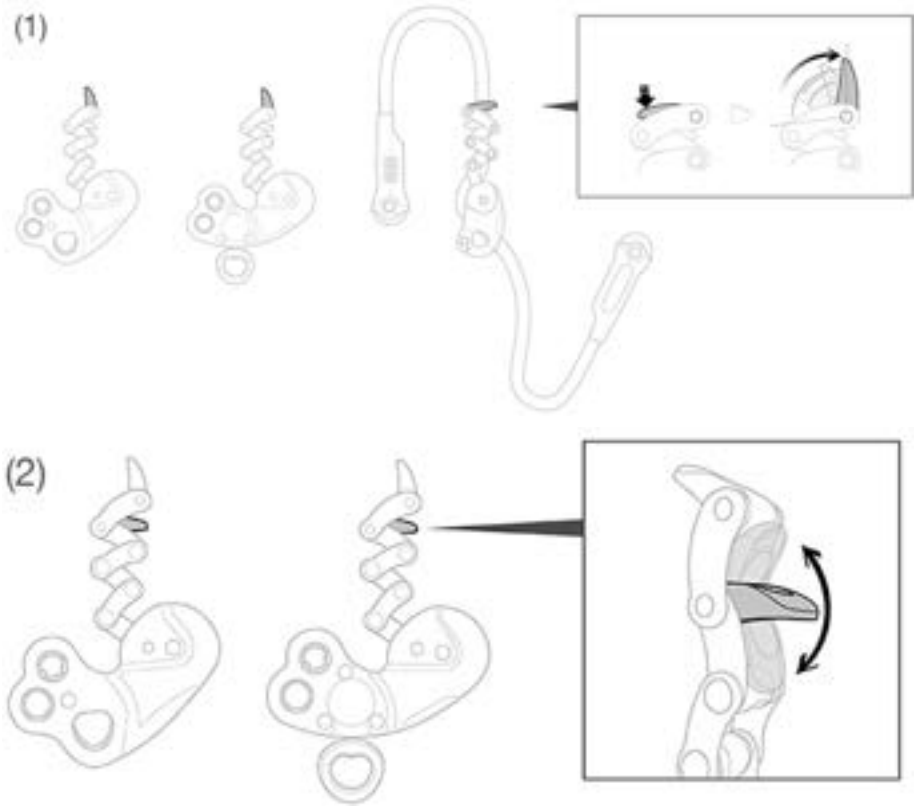
1. Inspecting the release levers

Item Name	Inspection Parts	Serial Numbers Affected	Notes, Reference documents, images, comments, etc.
Petzl ZigZag/ Zillon	Action: static load test in SRS (Zillon), function test in MRS, Check both release levers	18L-0000000-000 through 21G-0000000-000	Zillon lanyard - Use with only Petzl replacement ropes
			PetzlZigZagZigZagPlusZillon_SafetyNoti…

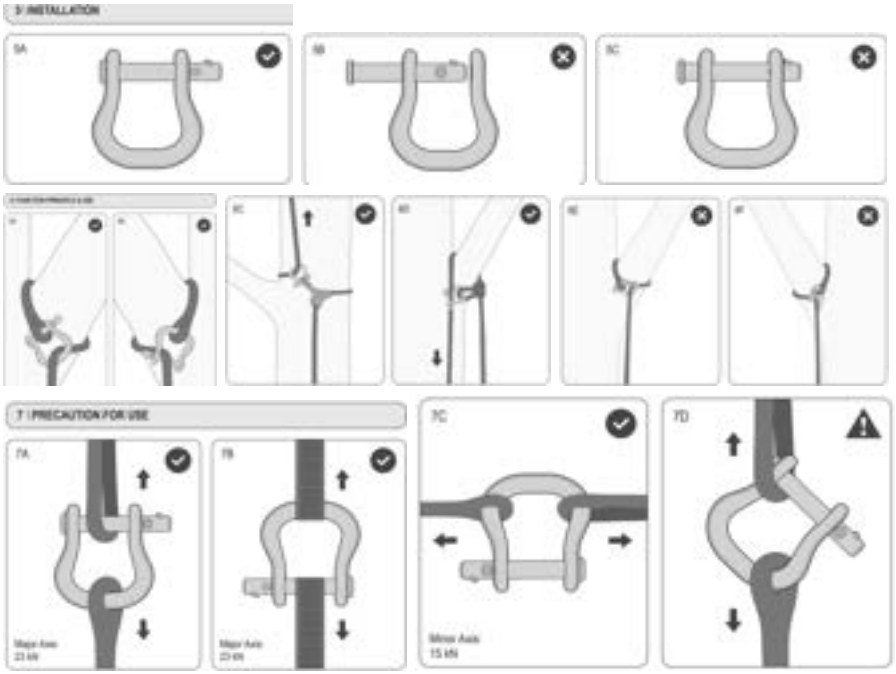
Notch CE Quickie	See configuration diagrams Notch_QuickieCE_UG.pdf
